ISSUES AND OPTIONS FOR
ECOLOGICAL RESTORATION
OF TE ROTOKARE AND
ITS MARGINS

FEBRUARY 2011

Report No. 2386

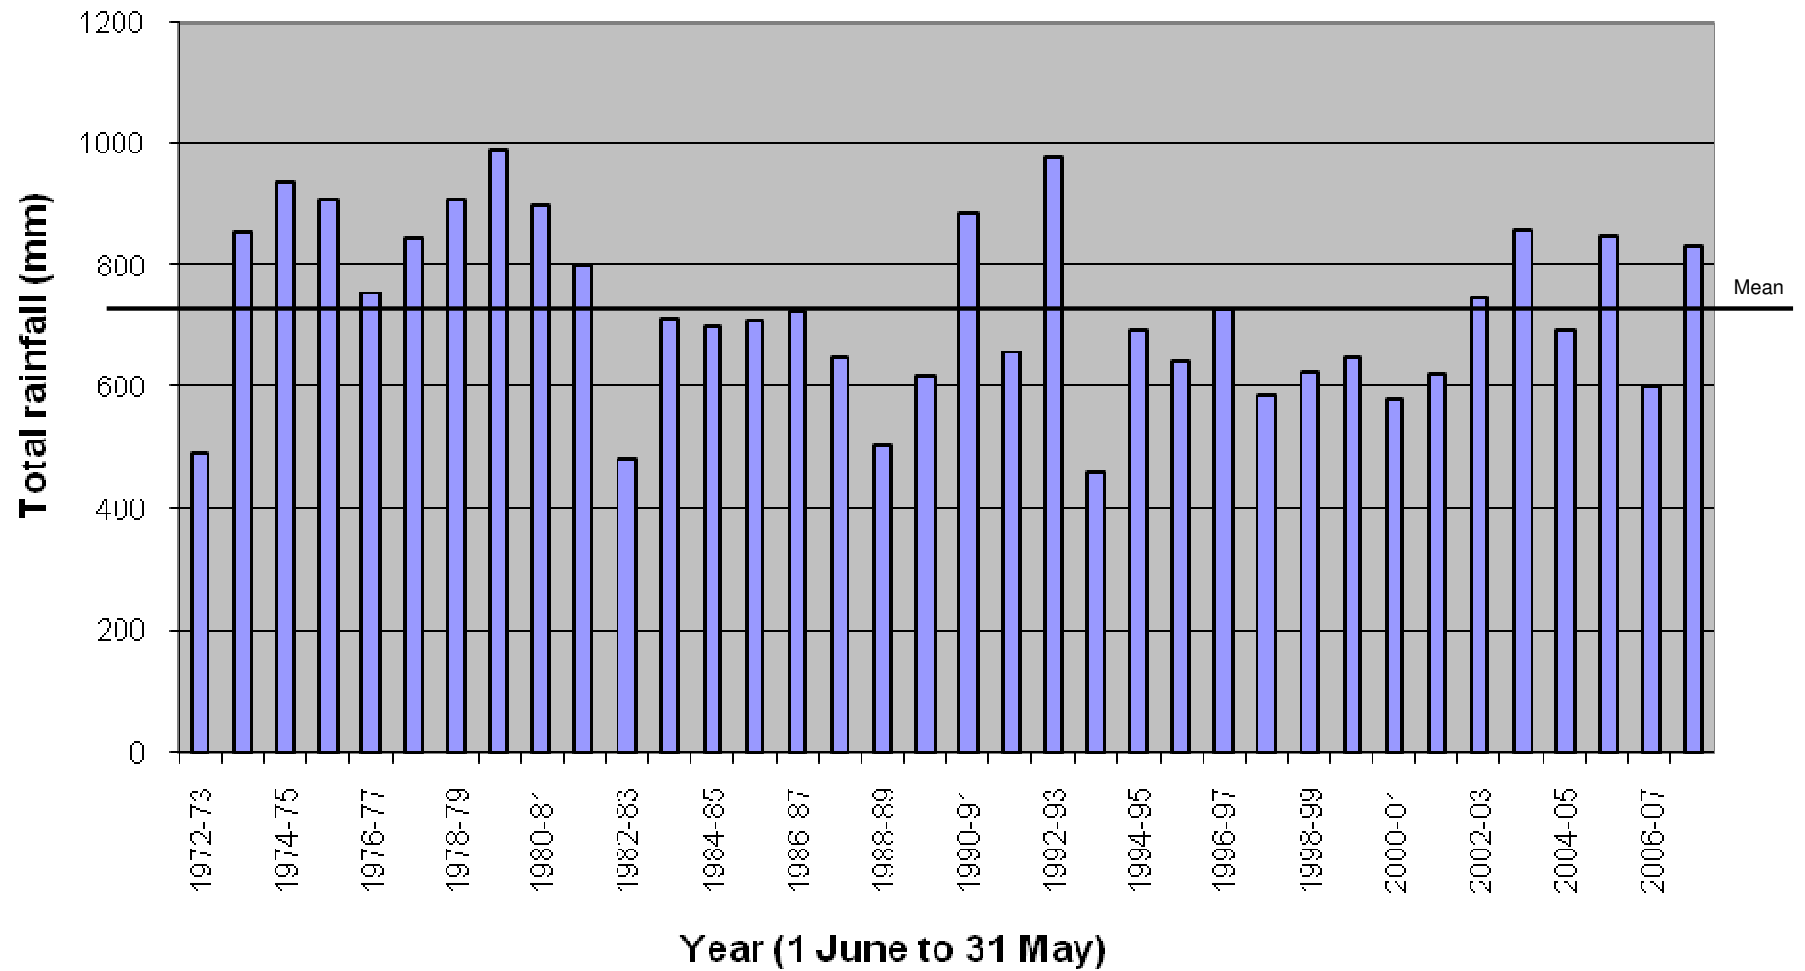
Figure 6: Annual Rainfall Ngatarawa 1972-2008

available, but rainfall records are, and these have been measured in parts of the region for many years. Figure 6 presents annual rainfall data recorded at Ngatarawa¹ just south of Fernhill for the period 1972-2008. In addition to highlighting years that were particularly dry or wet, these records indicate that some decades have been wetter or drier than others. The 1980s were considerably drier than the 1970s, while the 1990s were drier again and for a more protracted period, total annual rainfall being well below a 36 year average for six out of the 10 years. The last decade, while experiencing some significant rainfall events in some years, have also been relatively dry over the decade as a whole, though dry years have been more regularly interspersed with wet years. Only time will reveal whether annual rainfall is trending downwards, but 127 years of rainfall data recorded in Napier itself between 1872 and 2008, suggests this pattern is nothing unusual over a broader time frame (see Appendix 3).

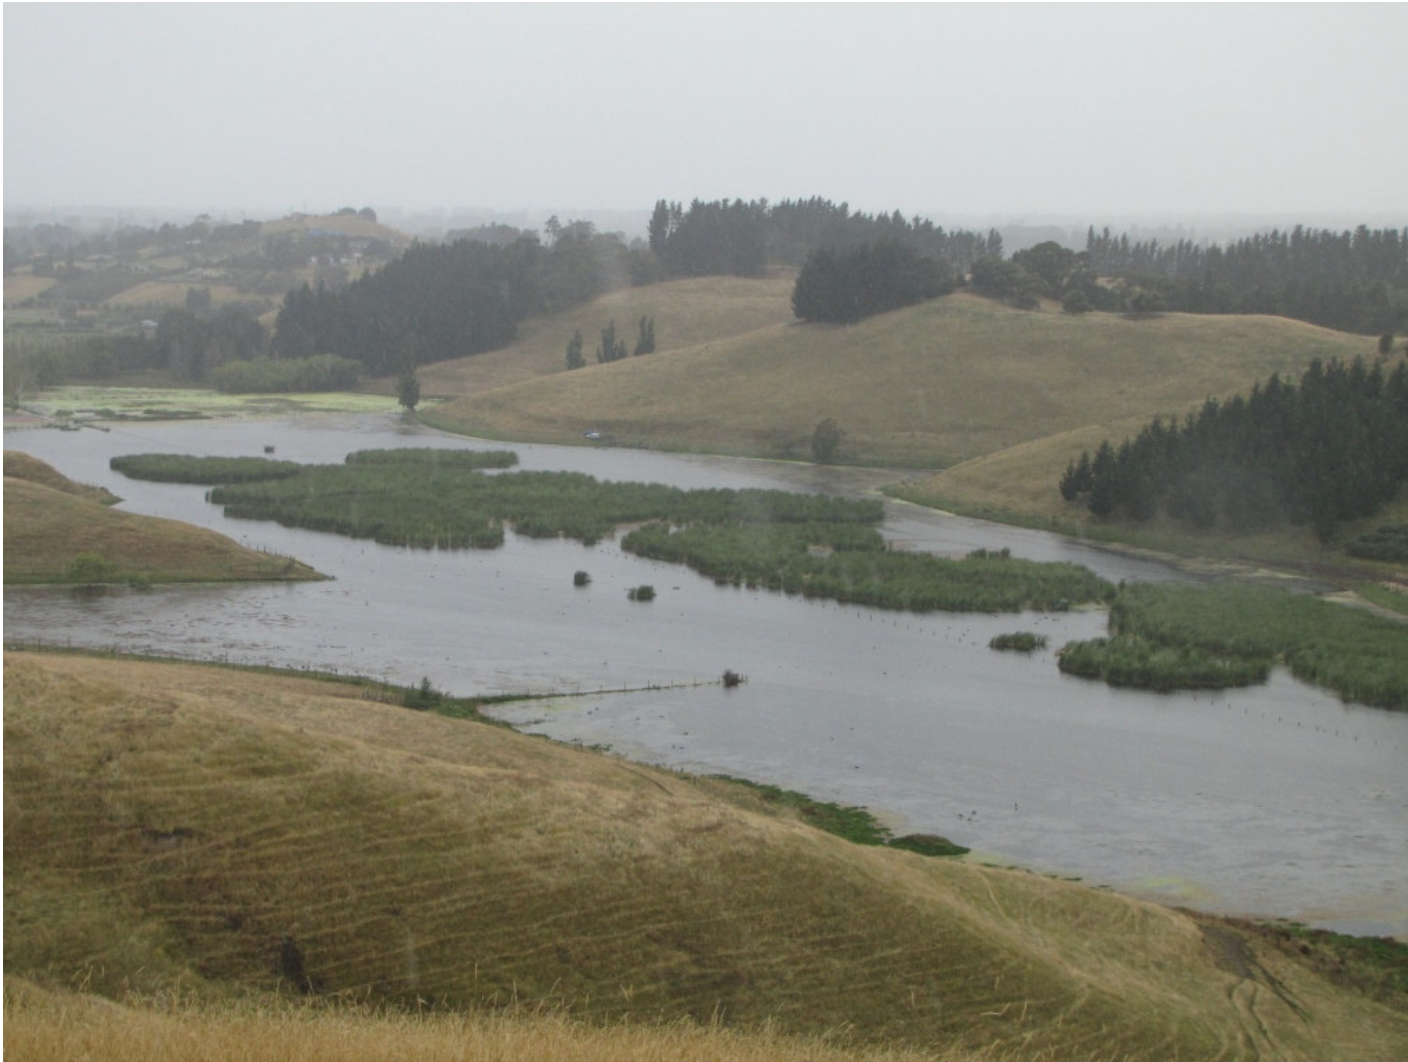
Plate 1: Main body of Te Rotokare as viewed from north-western end (21 January 2010).

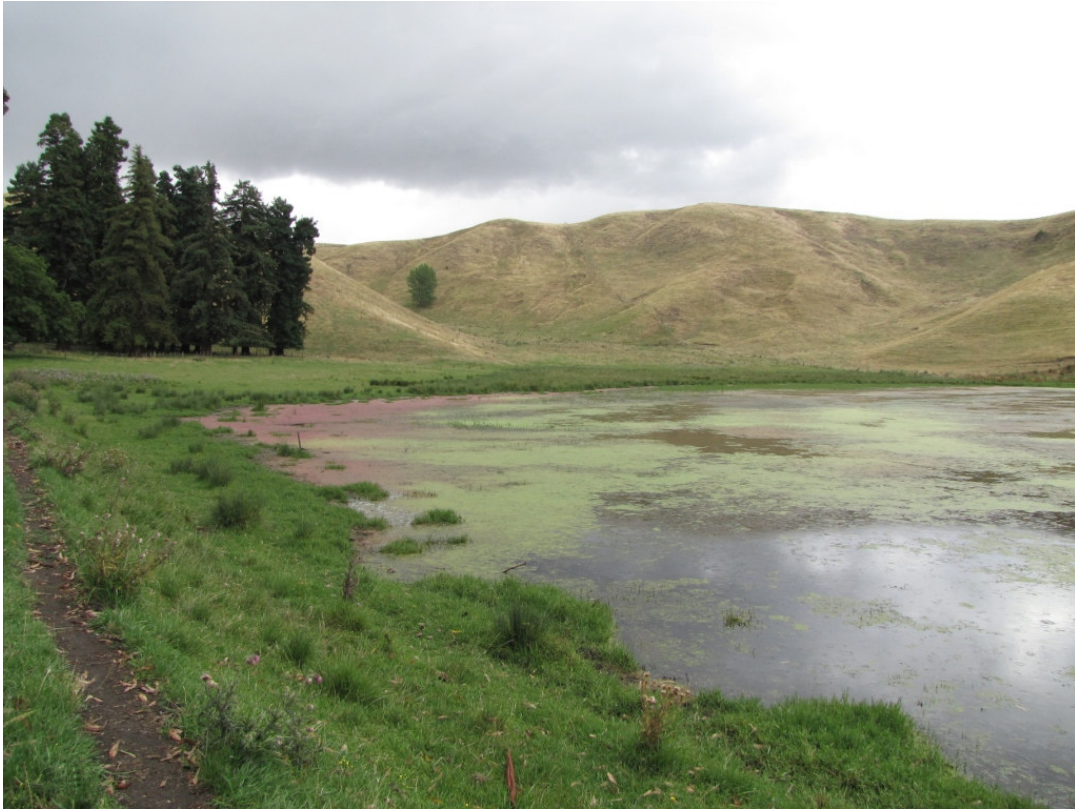
Plate 2: Upper (western) end of main water body (21 January 2010).

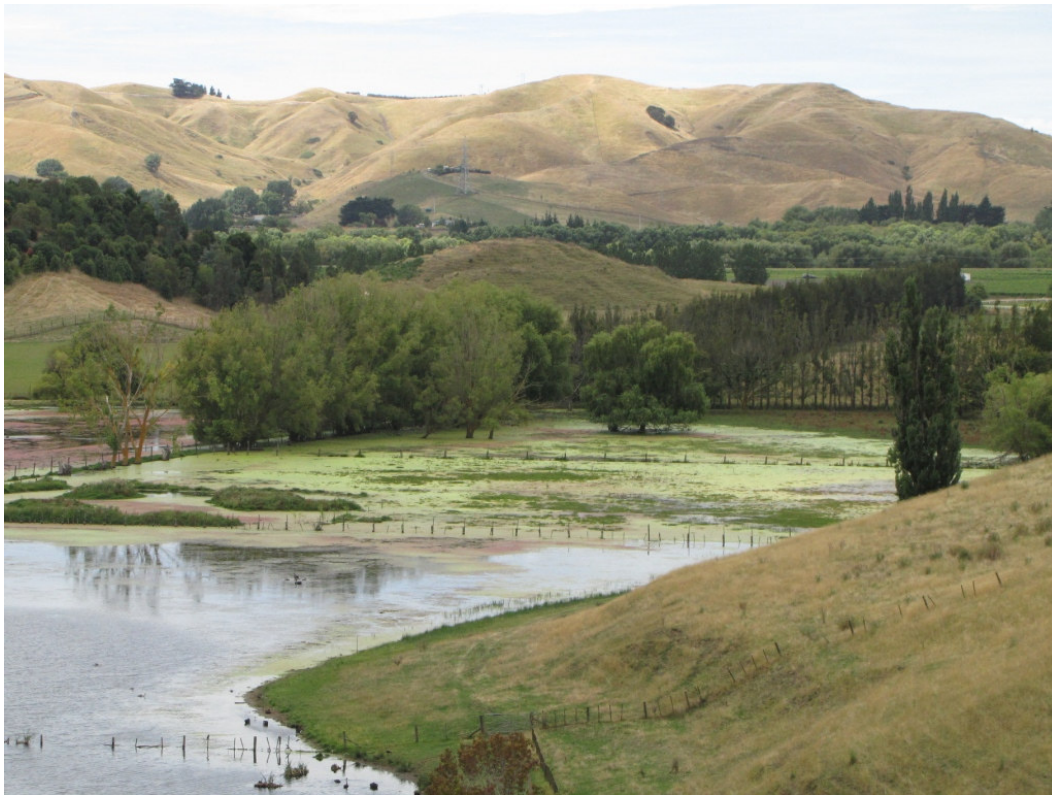
Plate 3: Lower (eastern) end of main water body (21 January 2010).

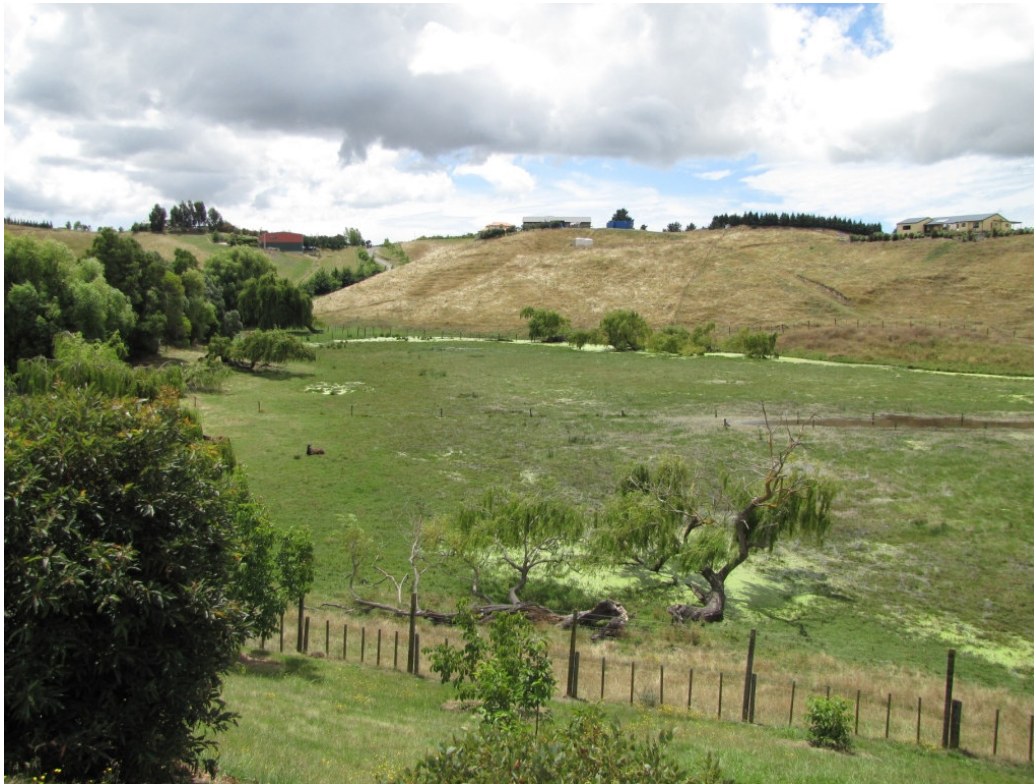
Plate 4: Upper (northern) end of north-east arm of lake (21 January 2010).

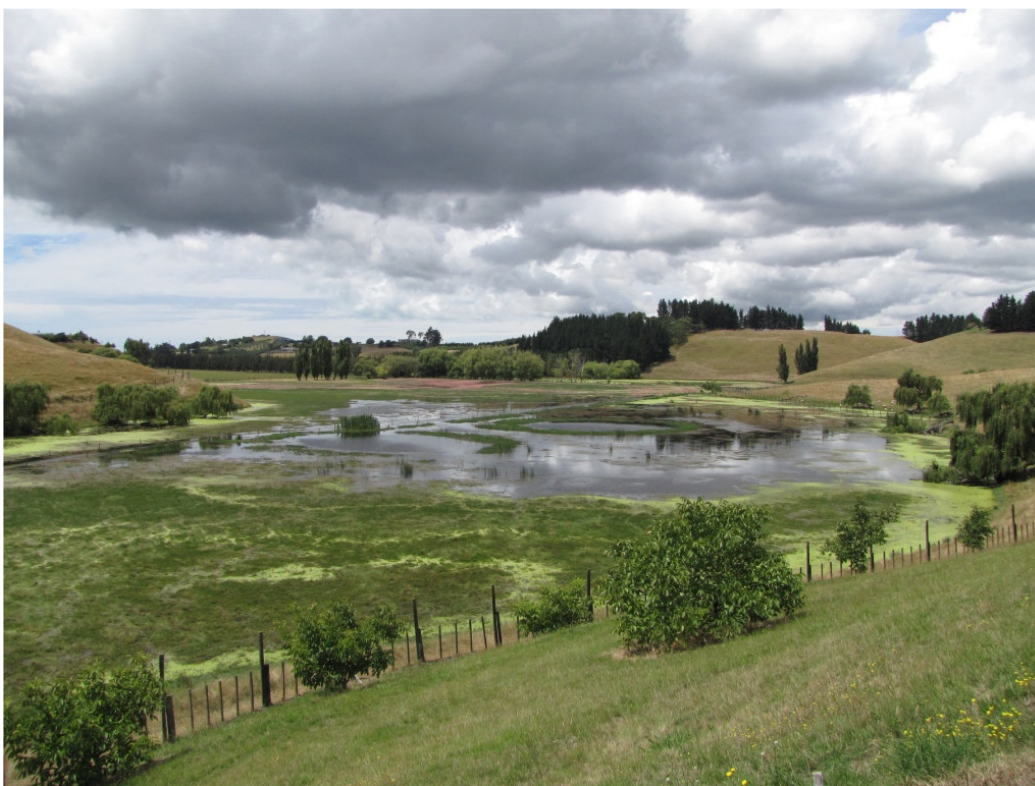
Plate 5: Mid and lower section of north-eastern arm of lake, looking south-eastwards (21 January 2010).

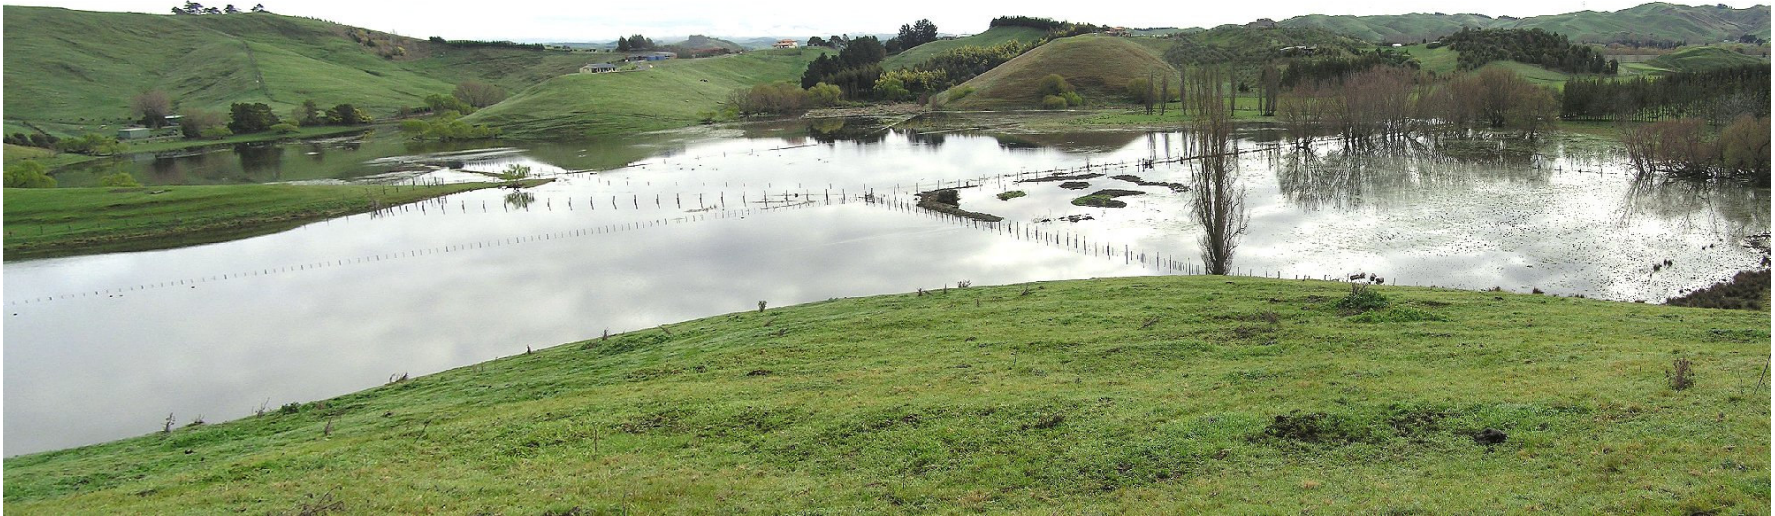
Plate 6: Te Rotokare viewed from southern side of lake looking across to north-eastern arm when water levels are high (September 2009). Photo supplied by Gary Williams.

Lake levels, and hence water depth and the extent of the lake can be highly variable during the course of the year (see Plates 6 & 7), and are heavily influenced by rainfall. Low levels can persist well into winter if the preceding summer has been a dry one, but heavy rainfall events can rapidly top it up again (Brendan McCormack, landowner, pers. comm.). Empirical observations of lake levels over time are not

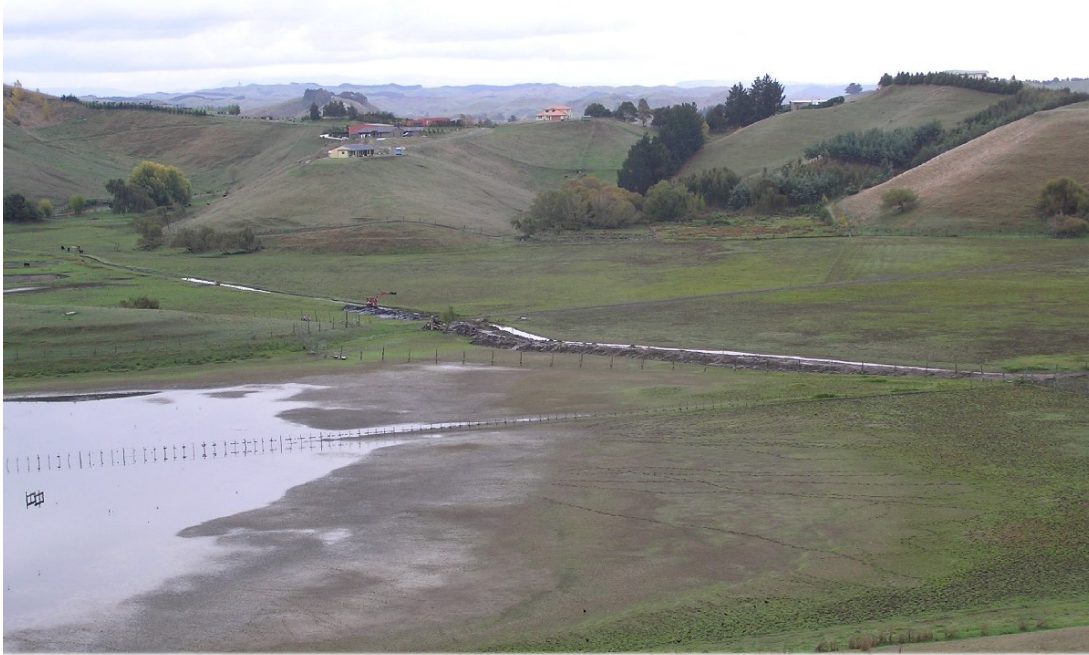
Plate 7: Eastern end of Te Rotokare viewed from southern side, looking into north-eastern arm when water levels are very low. Photo taken in 2007 by Gary Williams.

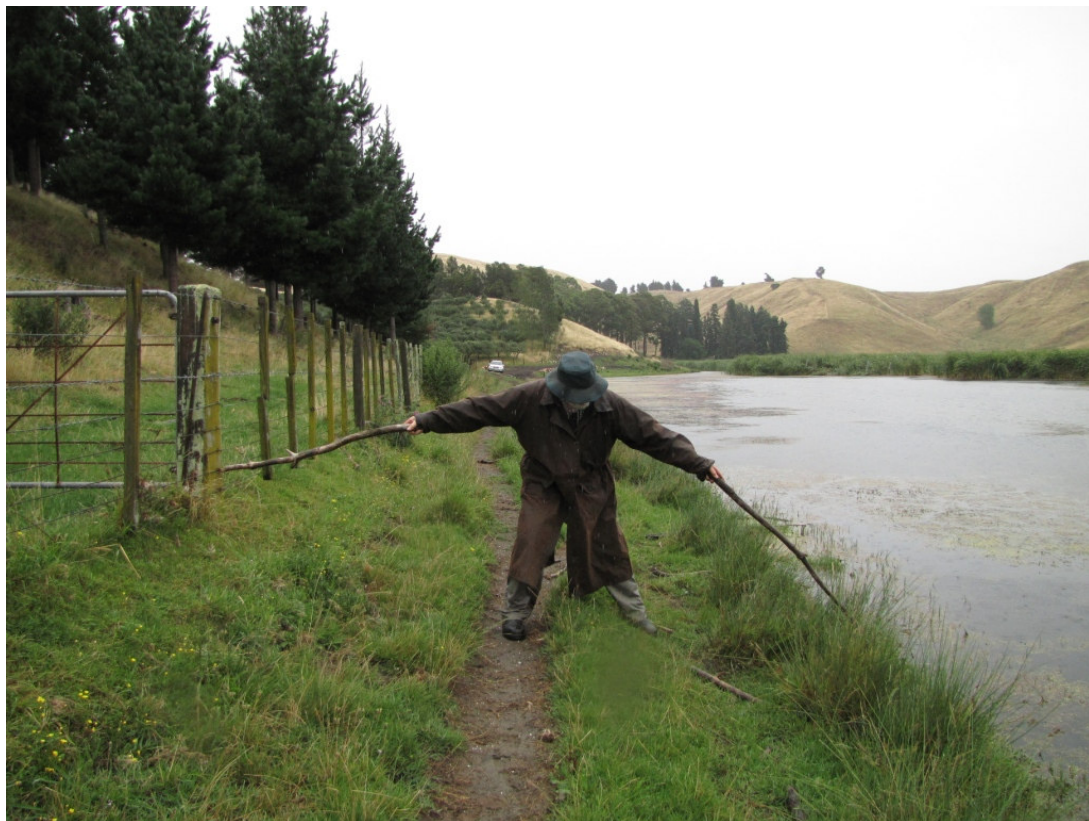
Plate 8: Gary Williams demonstrating the location of a former lake edge, relative to the present day margin (as viewed 21 January 2010).

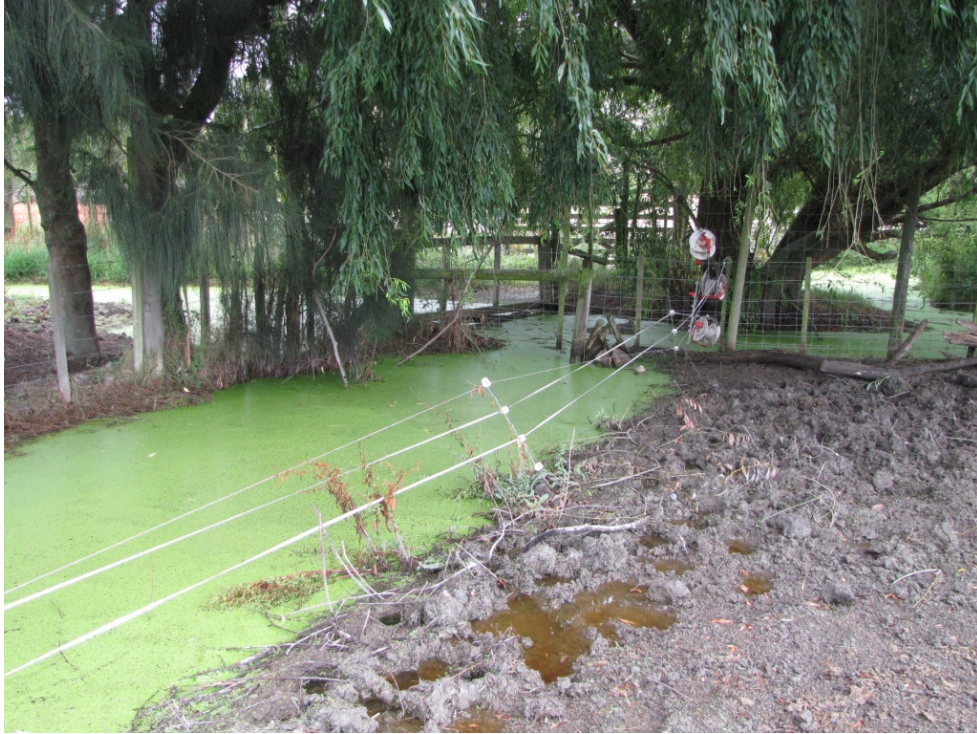
Plate 9: Outlet drain of Te Rotokare just below its junction with the southern cross drain (left mid photo) and the northern cross drain (entering from right mid photo). Note water level very close to surrounding ground level at this point. Photographed 21 January 2010.

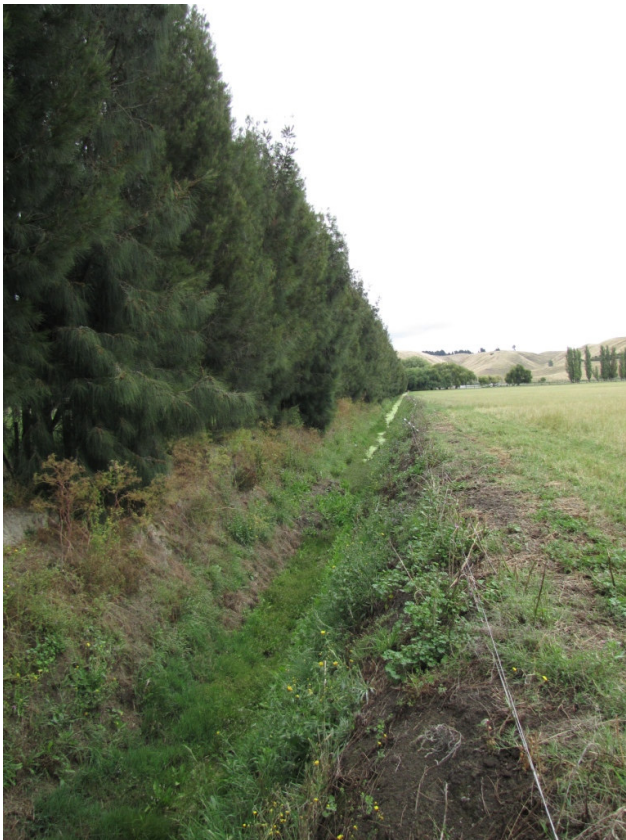
Plate 10: Te Rotokare outlet drain viewed from c.200 m below the lake which lies behind the trees in the distance. This photograph was taken on the same occasion as Plate 9. Note the depth of the drain and lack of water within it at this point which illustrates the extent to which ground level rise eastwards of the lake.
